clive h. hare, inc.,
16 ladyslipper lane,
arundel,
maine, 04046

Re:- Florida Exposure of Z.R.C. Cold Galvanizing Compound protected Steel
after ten years.

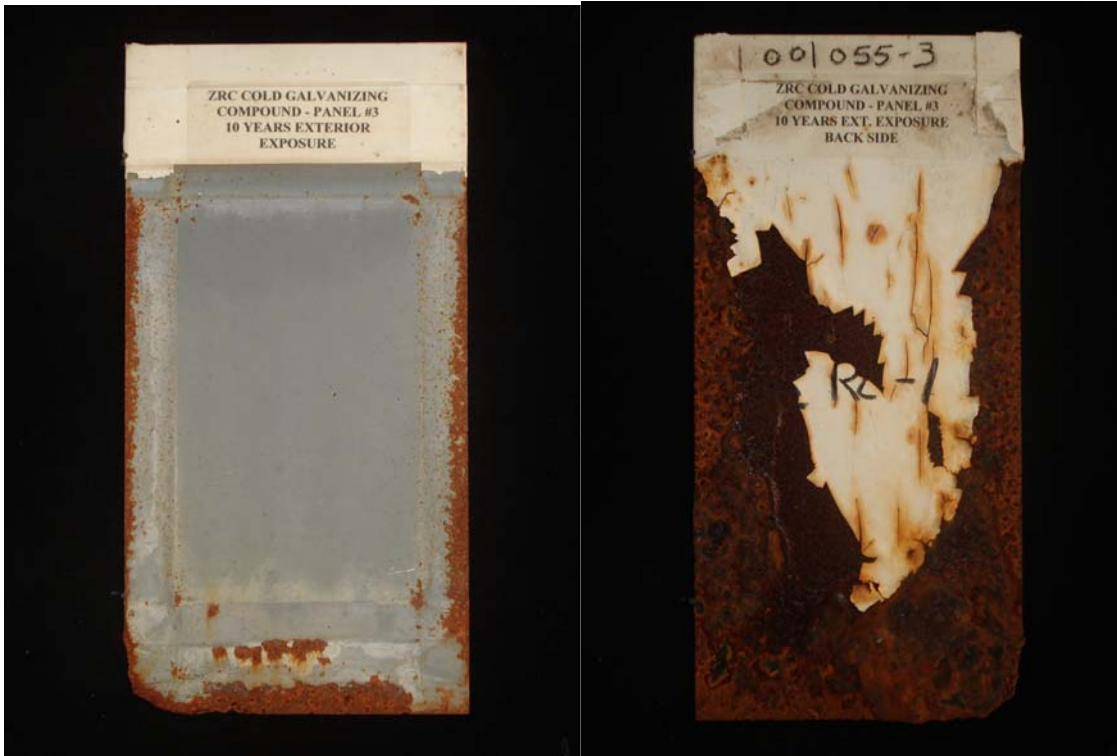
FIGURE 1: ZRC Panel No. 3 after 10 Years Exterior Exposure.

As may be noted from Table I the exposed face of each of the four panels remain excellent after 10 years. Some spotty ferric corrosion is seen at the edges of all four panels, but the exposed areas are, with one exception, universally protected and in excellent condition.

The white (zinc) corrosion is distributed across the entire exposed and zinc coated areas of all four panels which may be explained by the natural deterioration of the zinc powder (anode) which has successfully prevented the ferric corrosion of the under-film steel.

The level of performance noted is exceptional and surprising considering the range of ZRC film thicknesses evaluated. Panels #3 and #4 are less than 2 mils thick and yet continue to provide a most superior level of protection.

On the contrary the taped back faces of all four panels exhibit very severe ferric corrosion with associated scaling and pitting. The white tape has cracked and largely peeled from the backs and edges of all four panels.
